# Manhole Inspection Summary

Manhole # S43I\_\_034MH

Insp Date: **4/29/08 1:05 PM**

**Location** Address: **1724 bank st**

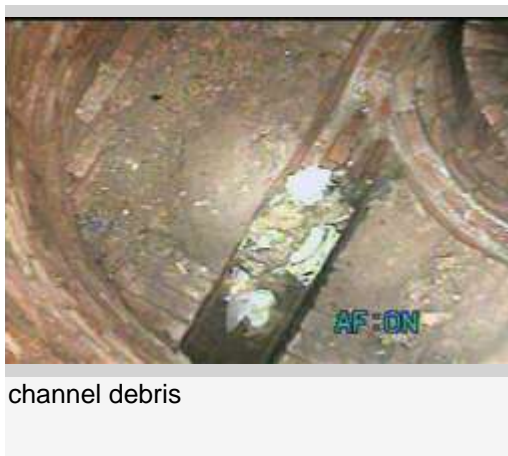
Defect 3

☒ **Debris**

channel debris

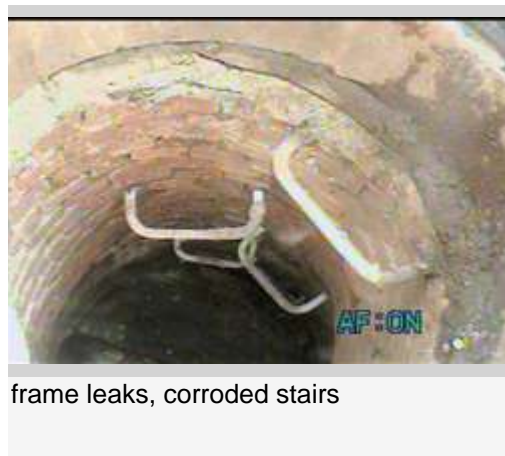
Defect 2

☒ **Leaks**

☒ **Corroded**

frame leaks, corroded stairs

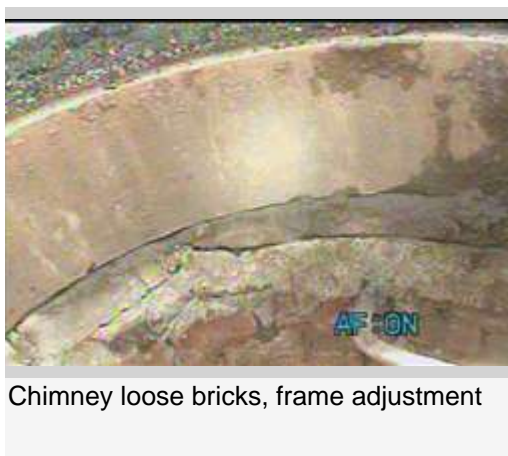
Defect 1

☒ **Loose Brick**

Chimney loose bricks, frame adjustment

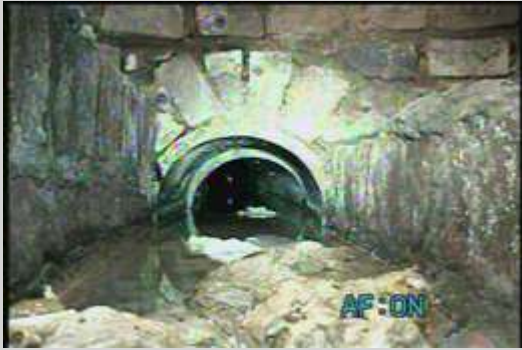
6 O'Clock Inflow

Deposits: ☐ None ☐ Mud ☐ Sludge ☒ **Debris** ☐ Grease

Silt Depth: **1** (in.) Deposits Extent: **Light**
